TF23166A
Albion Sidewalk Improvements & Whitman St
Reconstruction
Whitman St.
Albion, ID 83311

Title	Description	Number
Daily Field Report	2023-11-29 Technician- CAMBRIA UMBAUGH Reviewer- CHARLES VANCE	0074-000002
Daily Field Report	2023-11-28 Technician- BRANDON CONRAD Reviewer- CHARLES VANCE	0074-000001

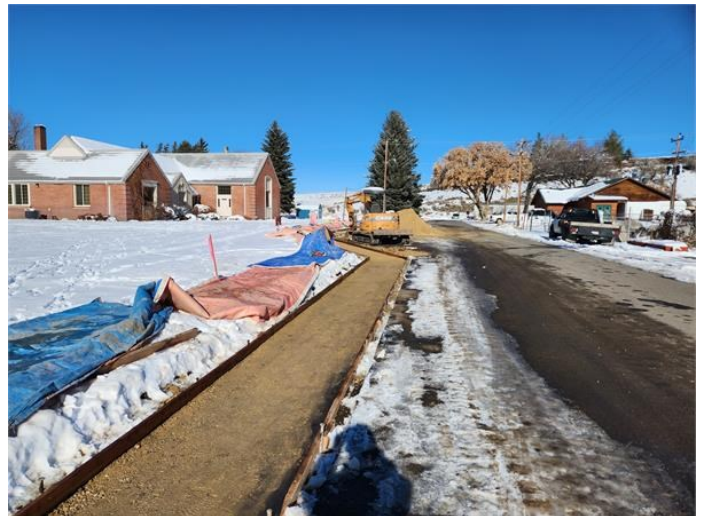
Subject: Vaughn Street sidewalk looking North.

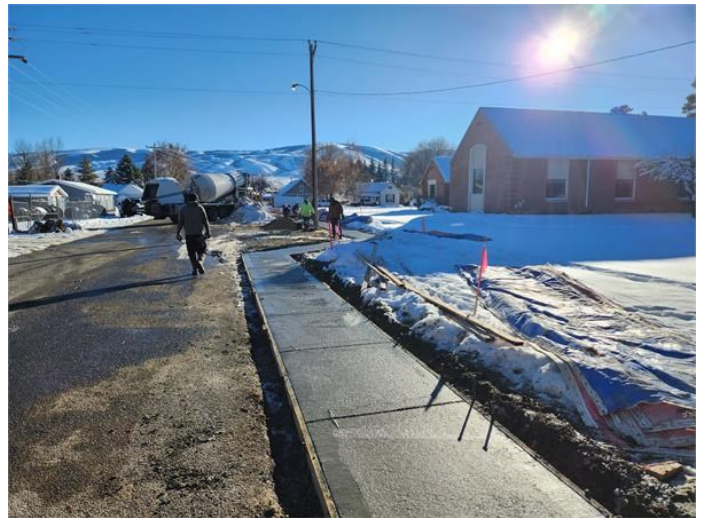
Subject: Concrete placement via truck and chute.
